## KAERI Feeder Tube Inspection Using EMAT Generated Circumferential Guided Waves

**Objective:** Inspection of small diameter pipe with complex curves. The principal defects of interest are axial cracking at bends.

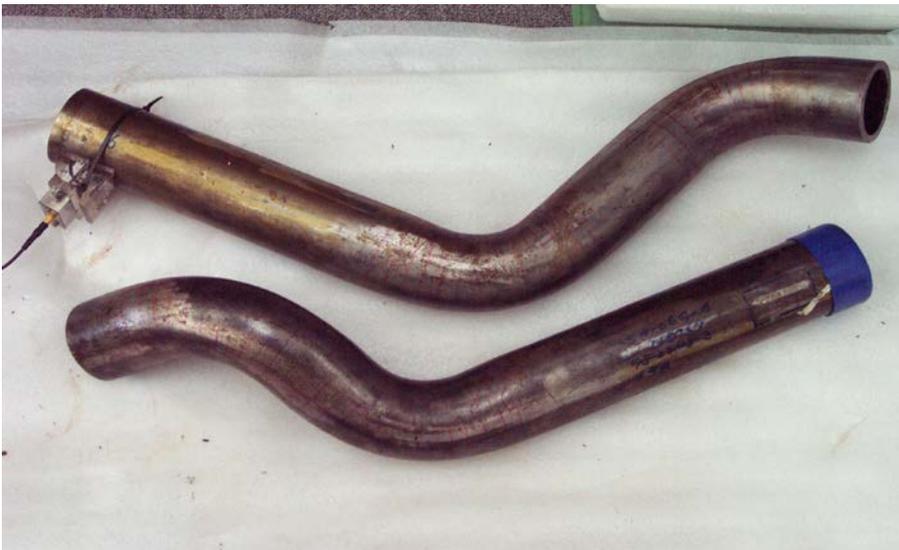
Figure 2: Sample pipes used in prototype development. One sample has an axial EDM notch in the middle of a bend the other sample is free of cracking.

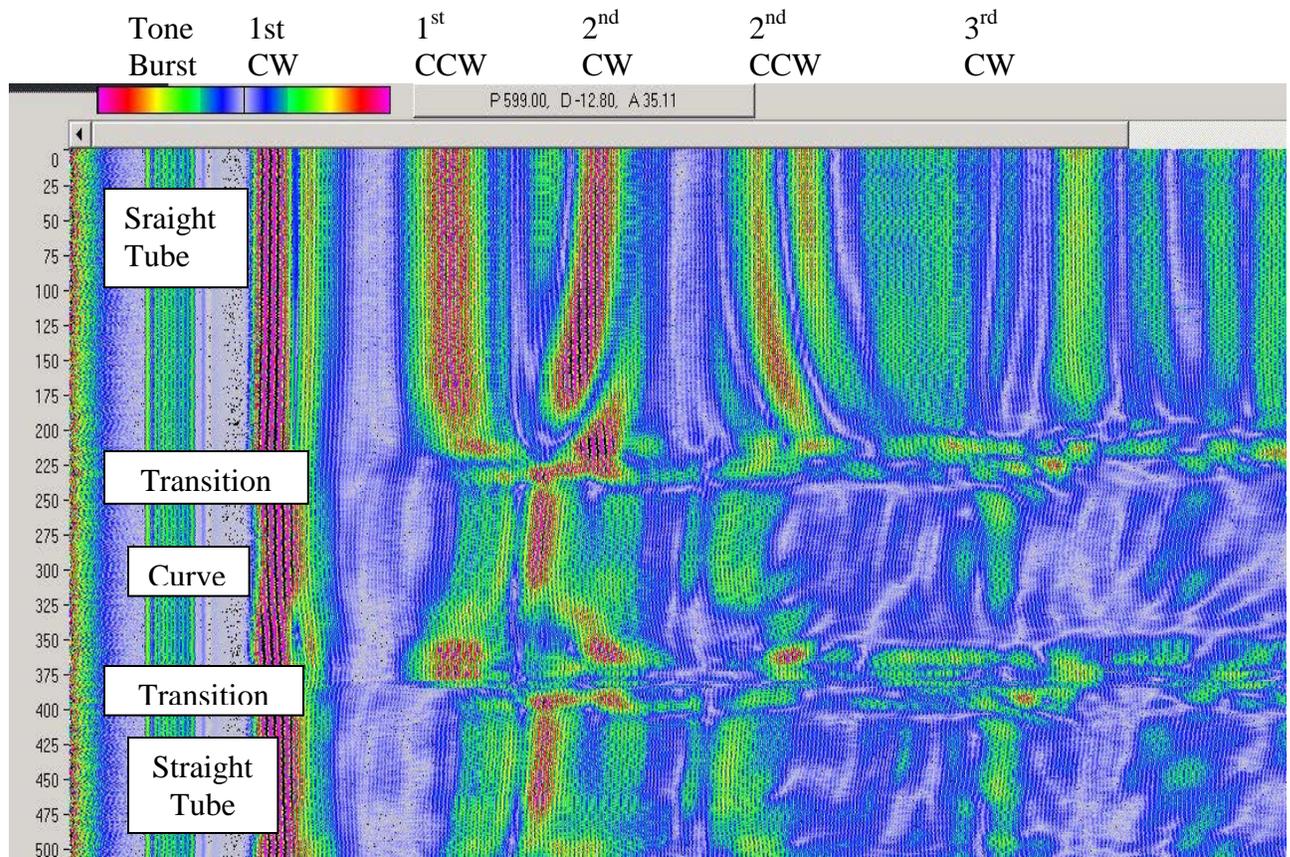
The Stacked A-Scan or E-Scan of Figure 4 displays the scan from straight pipe through a bend and into another straight. The vertical lines represent the various signals arriving at different times. These are labeled across the top of Figure 4.

**Figure 4: Scan of a feeder tube with out cracking. The Clockwise signals were labeled CW and the Counter Clockwise signals labeled CCW. Notice multiple revolutions around the pipe.**

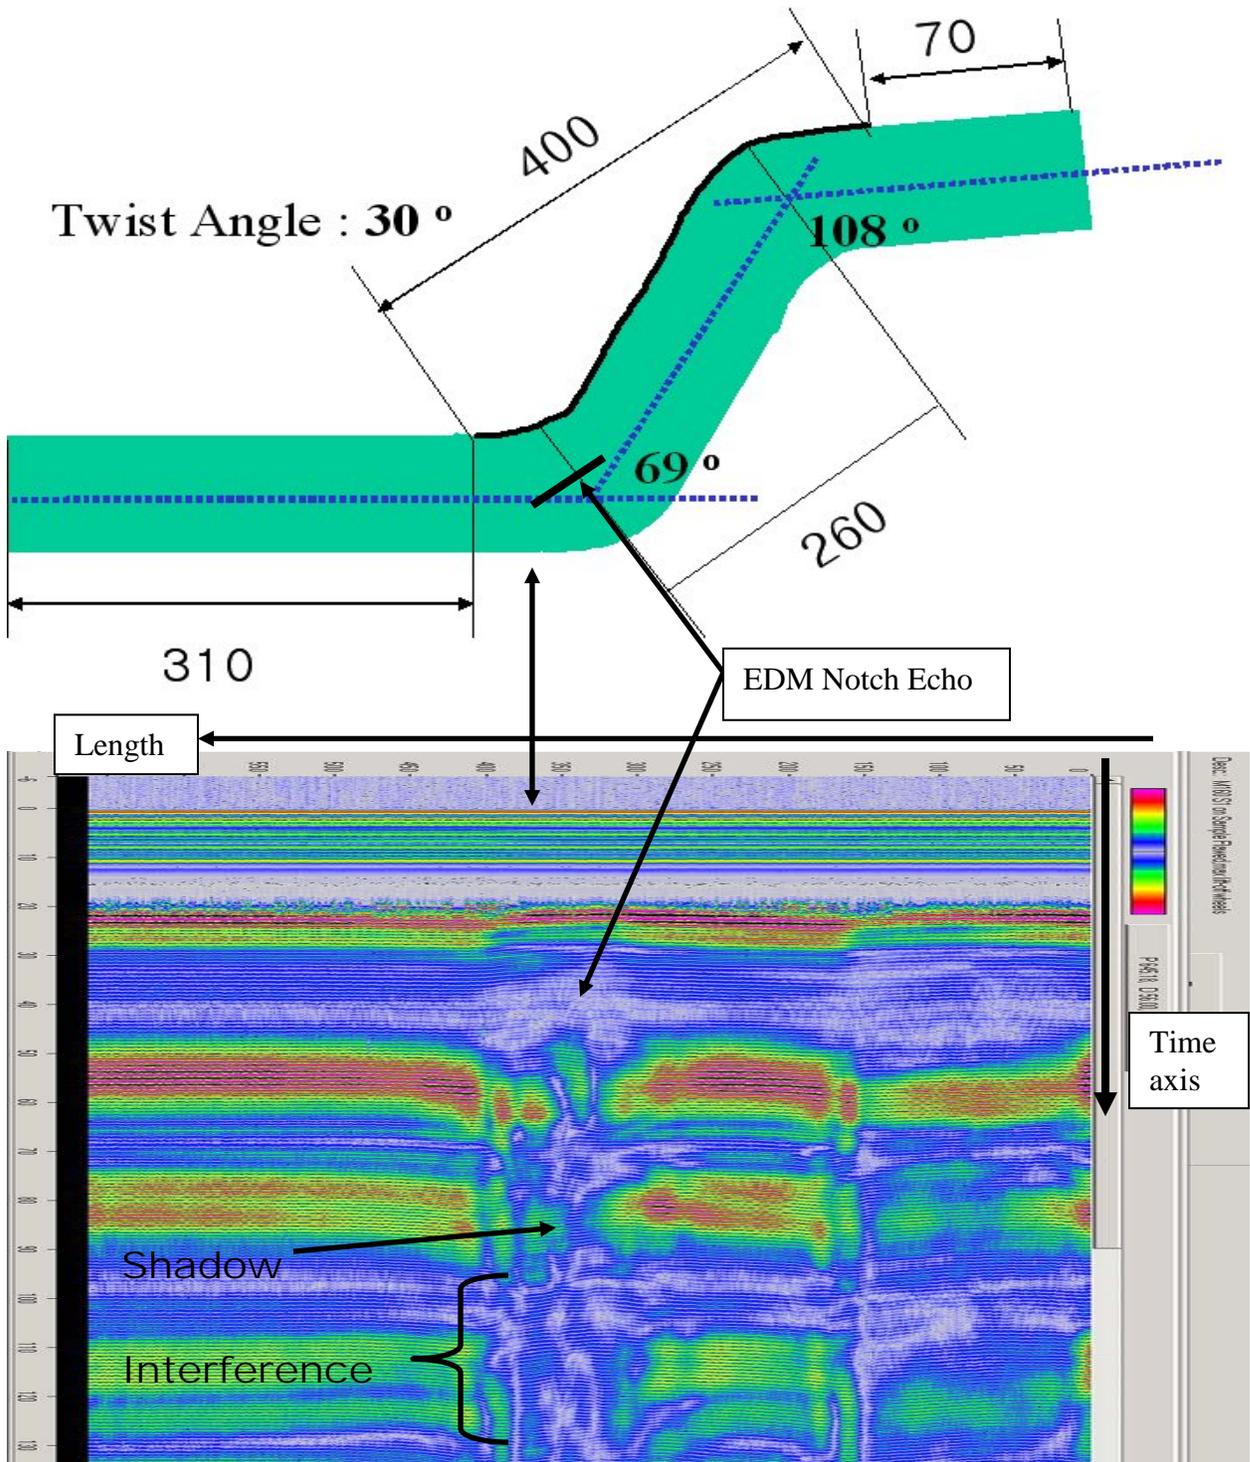
Figure 5: The Stacked A-Scan or E-Scan rotated 90° to align to the pipe illustration. The horizontal axis is the distance along the pipe, the vertical axis is arrival time of the acoustic signals. The color scale is the amplitude of the received acoustic signal shown in the upper right hand corner.

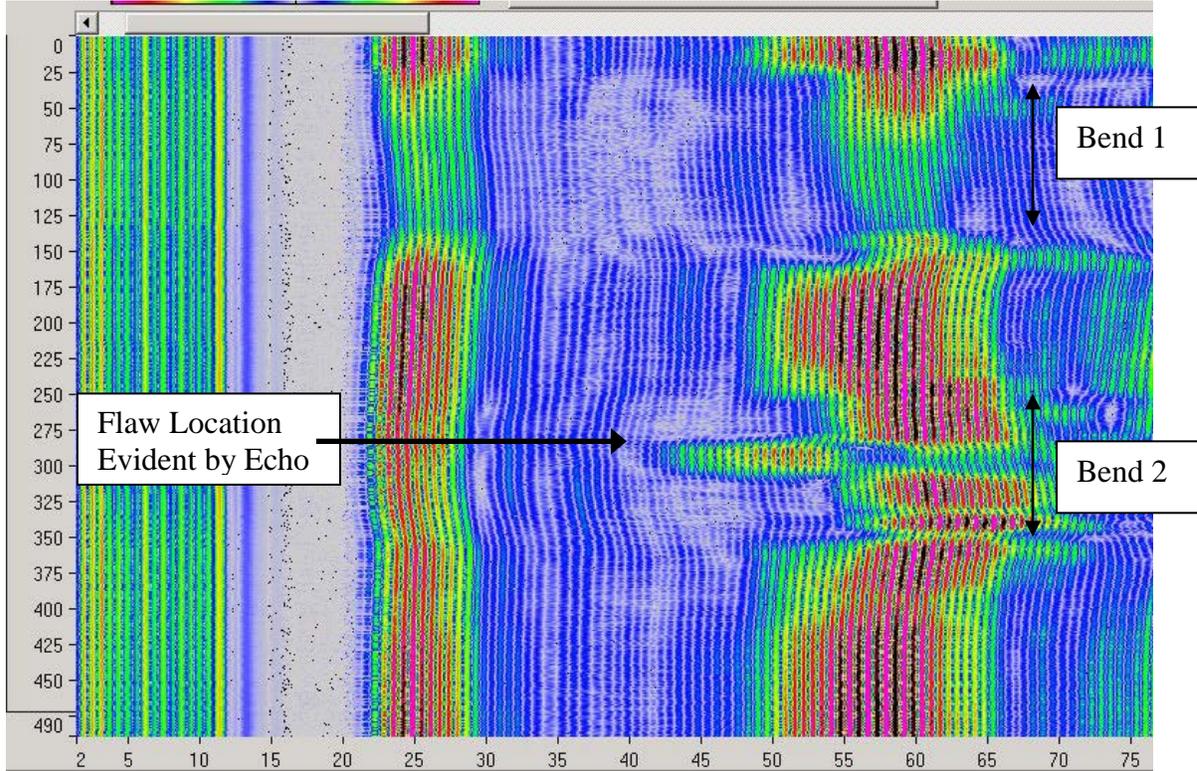
Figure 6: Sample pipe with axial EDM notch.

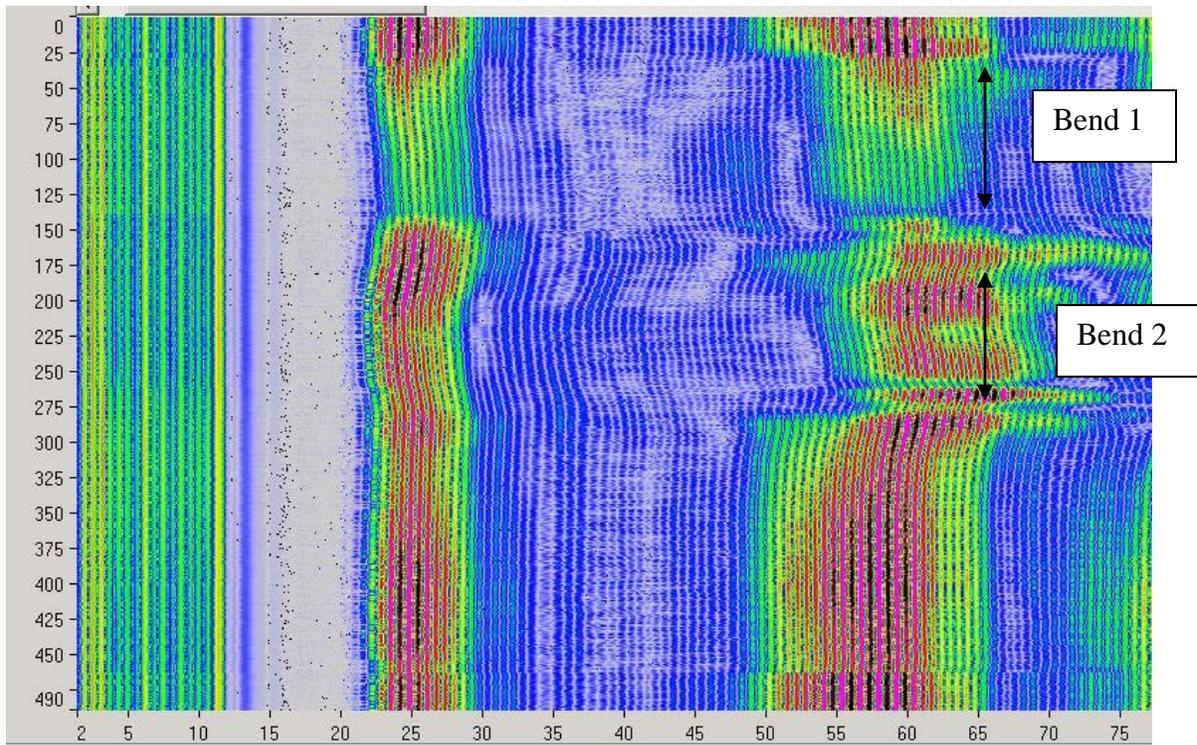
Figure 7: Sample pipe with out cracking, Flaw free specimen. No echo or shadow were present.

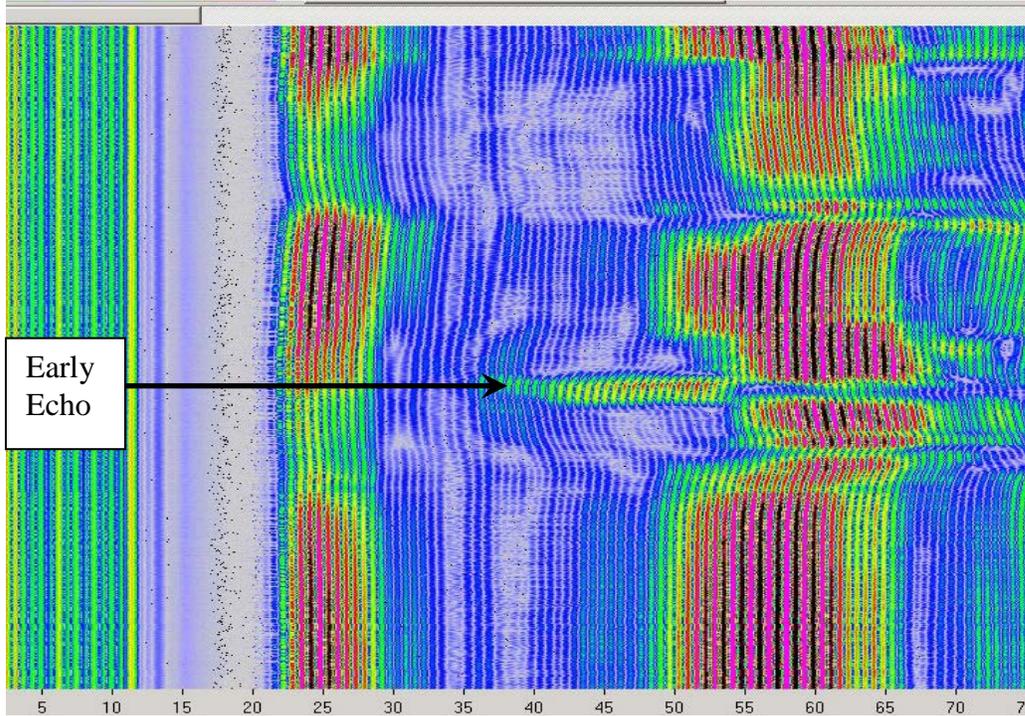
Figure 9: Example of an axial crack echo where the crack was close to the receiver and the echo occurred after the short path signal but before the long path signal.

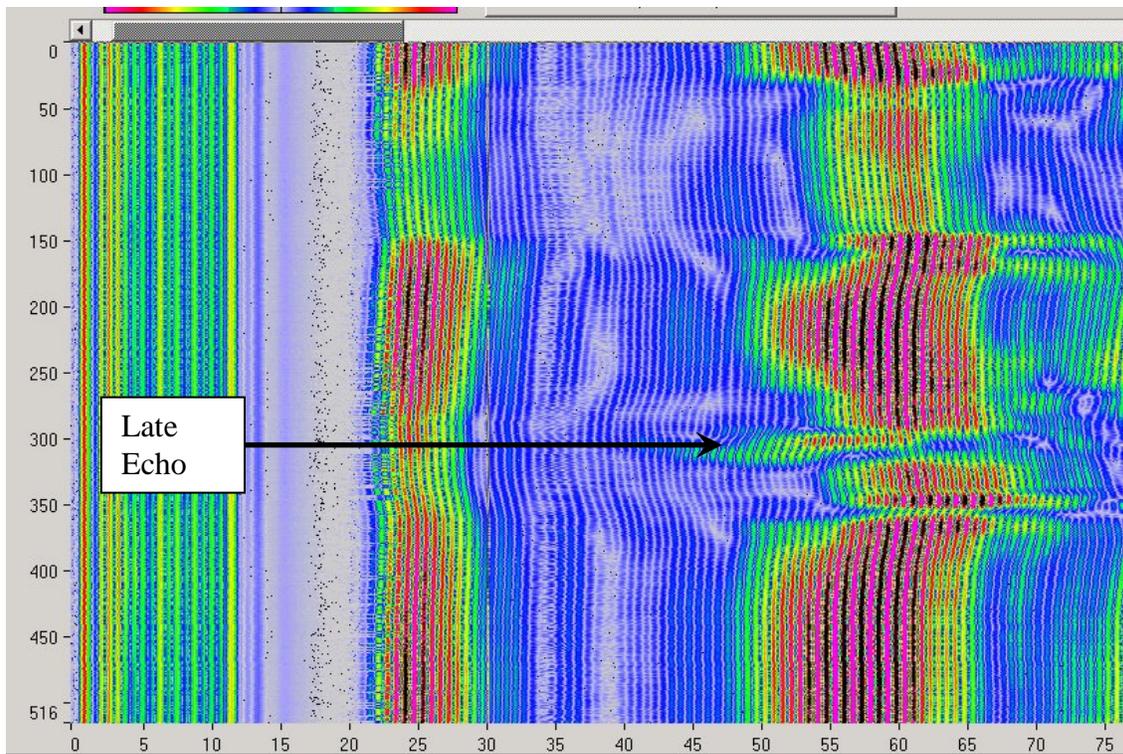
Figure 10: Example of flaw echo interfering with long path signal. This occurs when the axial crack was far from the receiver and occurred at nearly the same time as the long path signal.

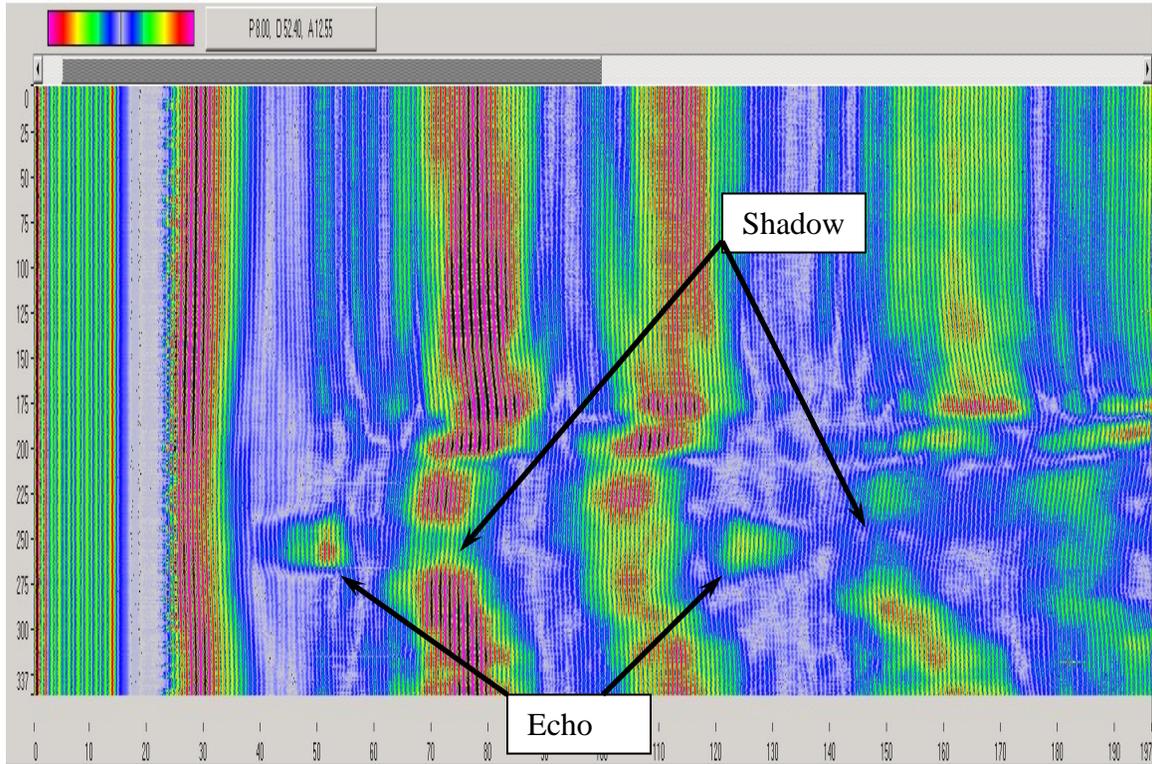
Figure 11: Shadow caused by an axial crack. Note the lack of signal amplitude behind the echo.
