# Technology Driven Not Operator Dependent

## **Advanced MFL Tank Inspection with STARS Top & Bottom Defect Discrimination**

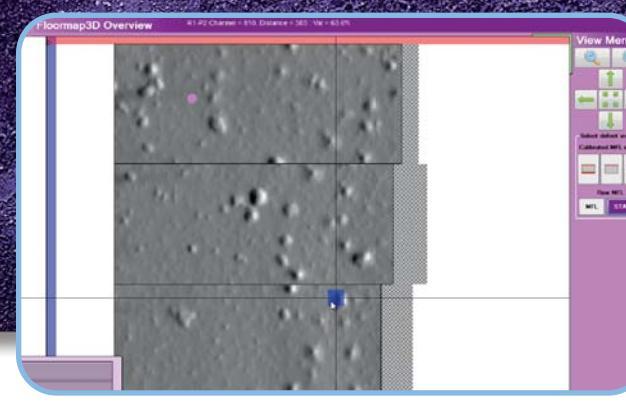
Top surface profile with STARS technology

The innovative STARS technology (patent pending EU: GB105193.5, GB1110889.1, GB1109371.3 and USA: 13175440) adds an additional set of sensors to detect variation in magnetic field strength caused by top side defects, and combines this with traditional MFL indications to identify top or bottom location. The Floormap3D has a total of 256 sensors, enhancing lateral resolution to detect smaller defects, and reduce sensitivity to defect orientation.

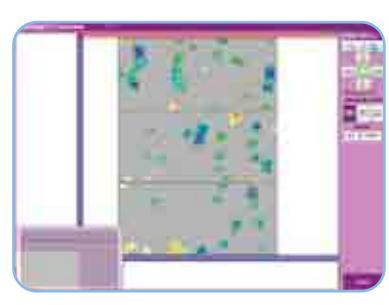
Scanned plate

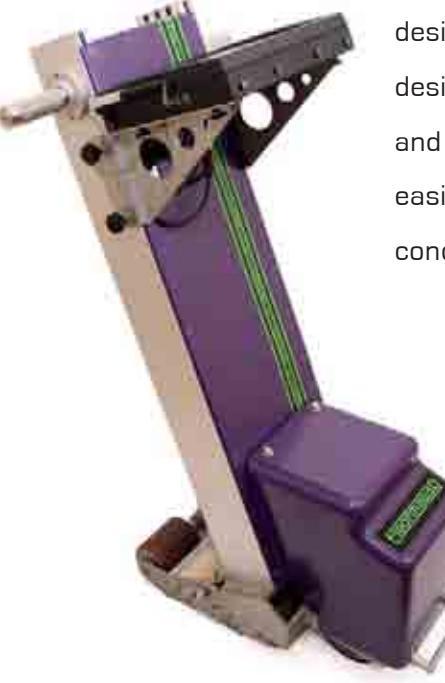
Large button user interface

The on-board computer uses touch screen technology and proven user interface design for ease of use within the hostile storage tank environment. The custom designed data acquisition software not only captures all the MFL signals but analyses and displays the location and severity of the corrosion in real time. The operator can easily select to view top, bottom or full defect maps, providing instant feedback on tank condition.

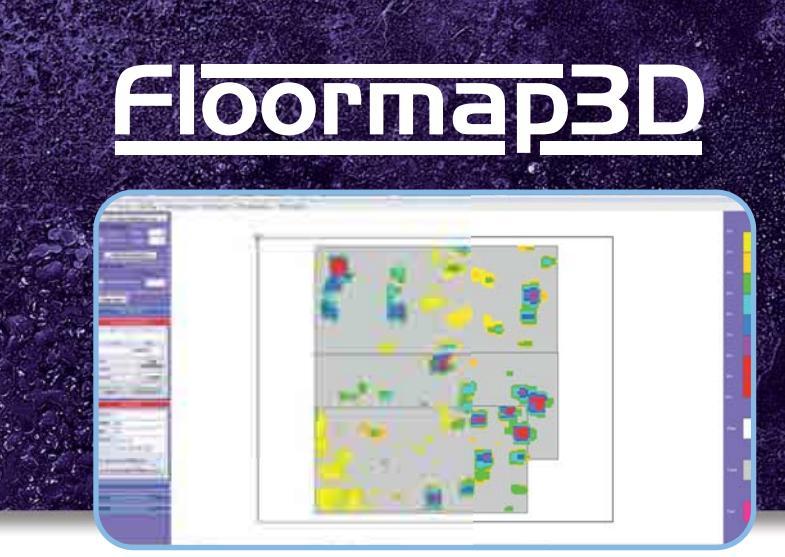
Plate view showing top & bottom defects

The Floormap3D reporting suite has the capability to view both the top surface and bottom surface corrosion on one screen with the option to view corrosion from either the top surface or bottom surface at the click of a button.

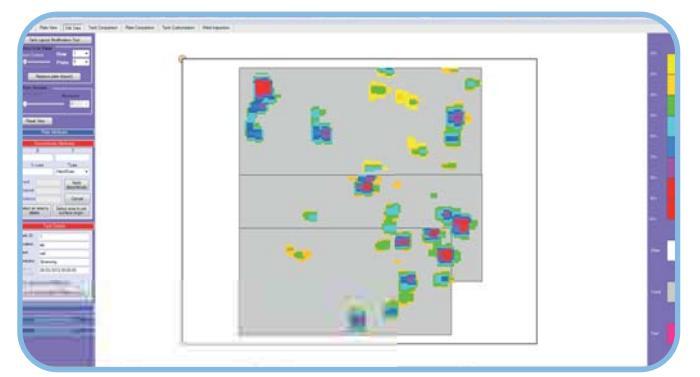
Plate view showing top defects

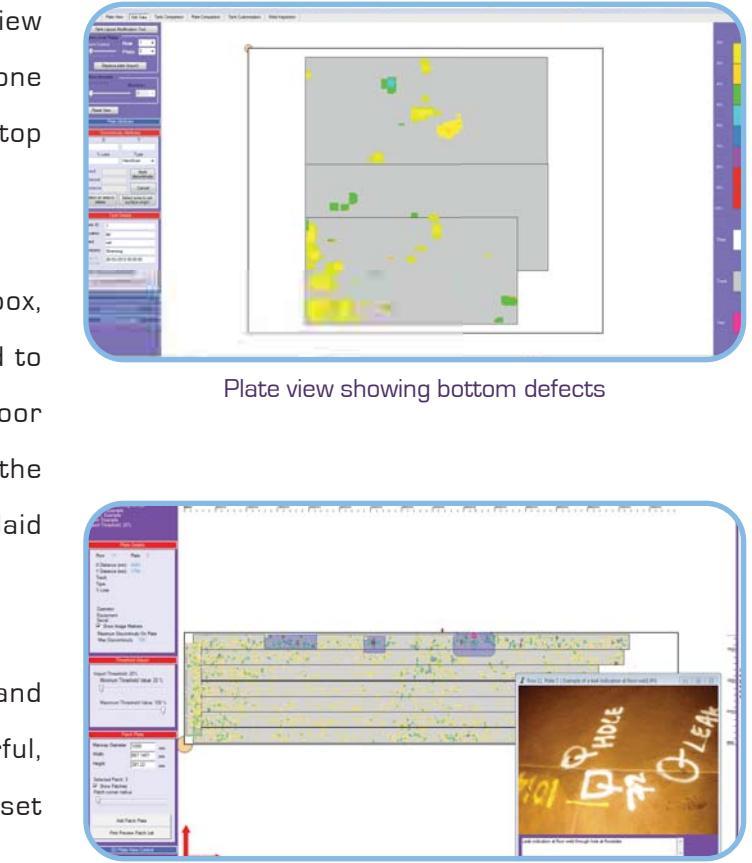
Add patch plates & photos

These features couple together with patch plate design and prove up functions give the tankage engineer a powerful, cost effective tool with which to carry out trending and asset life projections.
